## PARTIAL Forensic Analysis Report Sample

We have made a preliminary forensic analysis of one switch mode power supply used to power a #####, model #####\_##### switch. The power supply had failed catastrophically at the client's location, rendering the product unusable. There were no observations given by the client about the moment of failure of the unit.

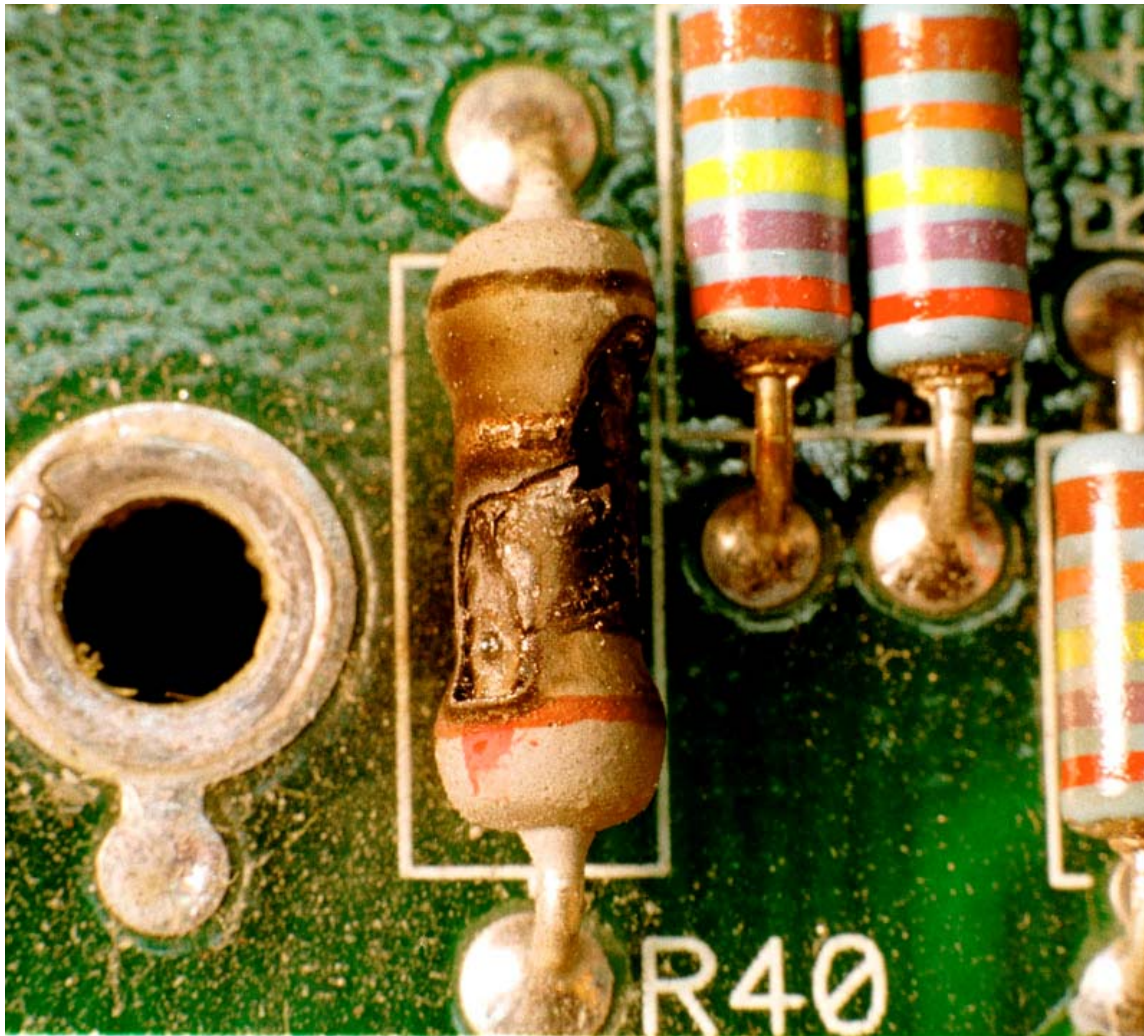
The failed unit did show visible signs of damage on certain components. Of note was a fixed resistor, R40 that had burn marks on the outer casing with vitrification of the resistive element. This failure mode can occur when an abnormally high current pulse passes through the component, causing extreme heating of the resistive element and subsequent fusion of the resistive element into a glassy substance. This resistor is located in the same circuit trace as the main high voltage capacitor C13, rated at 330uF/ 450VDC. Any fault in the power supply would cause current in the large

capacitor to seek a path to ground with the least resistance. Resistor R40, the lowest rated resistor in the vicinity of C13, has a power rating of 1W or less and would not be able to sustain a large surge of current. Thus failure of the resistor occurred when the fault was present in the power supply. (See picture below)

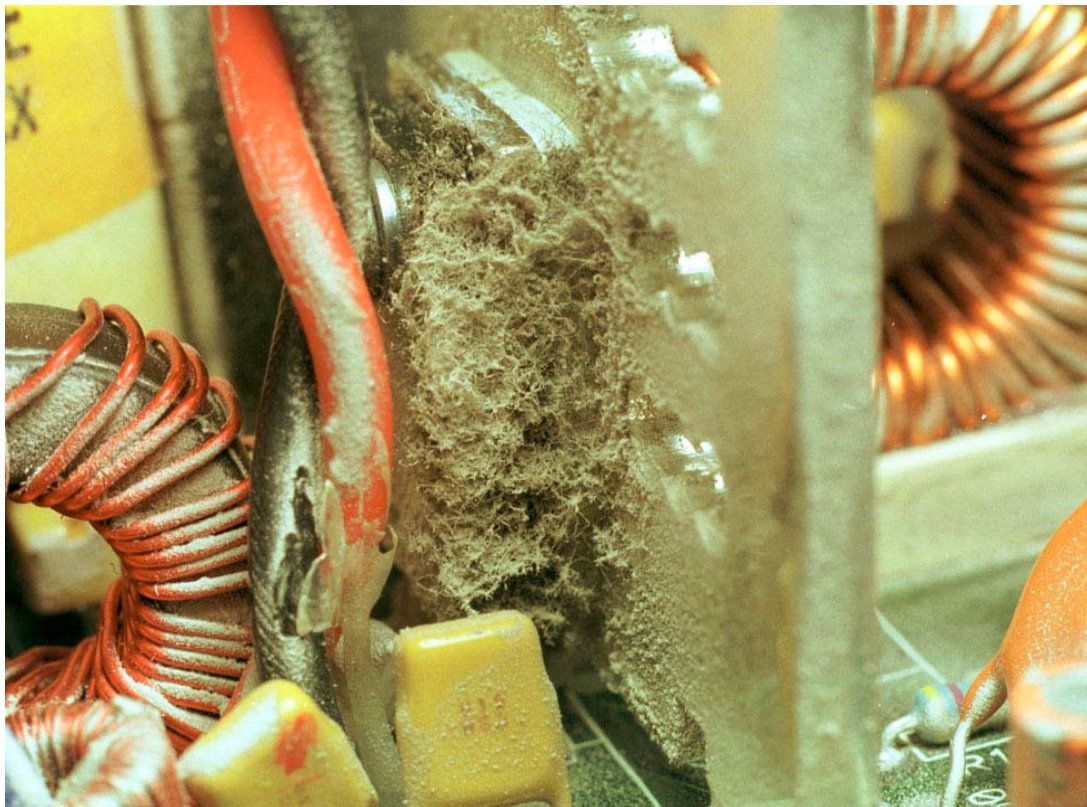
Upon disassembly of the power supply we did notice the presence of large amounts of debris on certain components. This consisted of dust and fibers that had adhered to the surfaces of semi-conductors and power resistors. Viewing of the debris under moderate magnification showed that several types of fibers were present in the debris. These included (and are not limited to) hair, plastic filaments, textile fibers, black filaments resembling carbon fibers and very small shiny strands. A complete analysis of the fiber masses was not conducted at the time of our investigation. The fibers bridged the gap between semiconductor ground plates and heat sinks used for cooling, as well as bridging one lead of AC high voltage resistor, R76, to the heat sink. Inspection of the metal chassis housing the power supply revealed a small protrusion of dust and debris on the metal plate that contacted the edge of the circuit board near component location fuse F2. (See pictures below).

Dust and debris at component location BR100

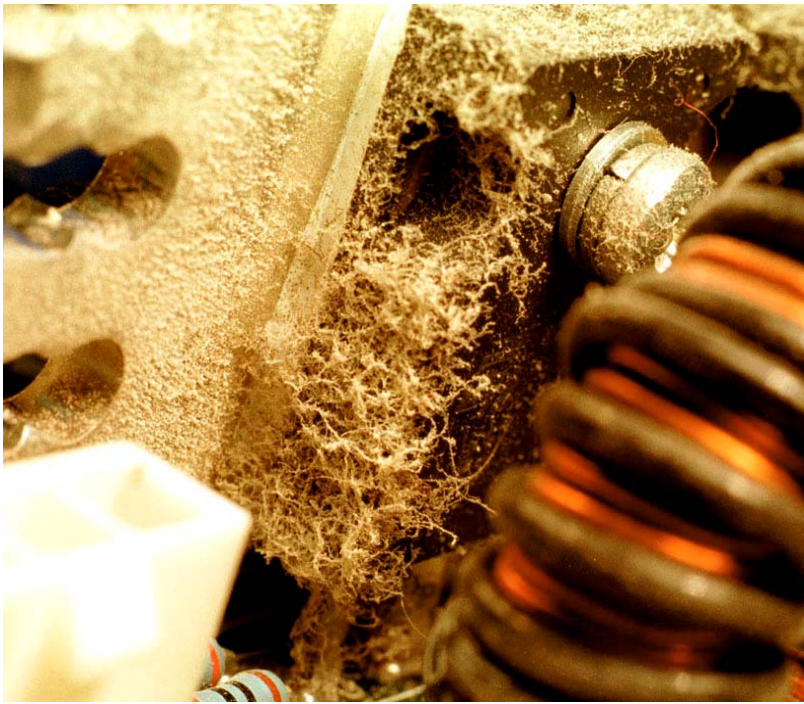
Dust and debris at component location CR24

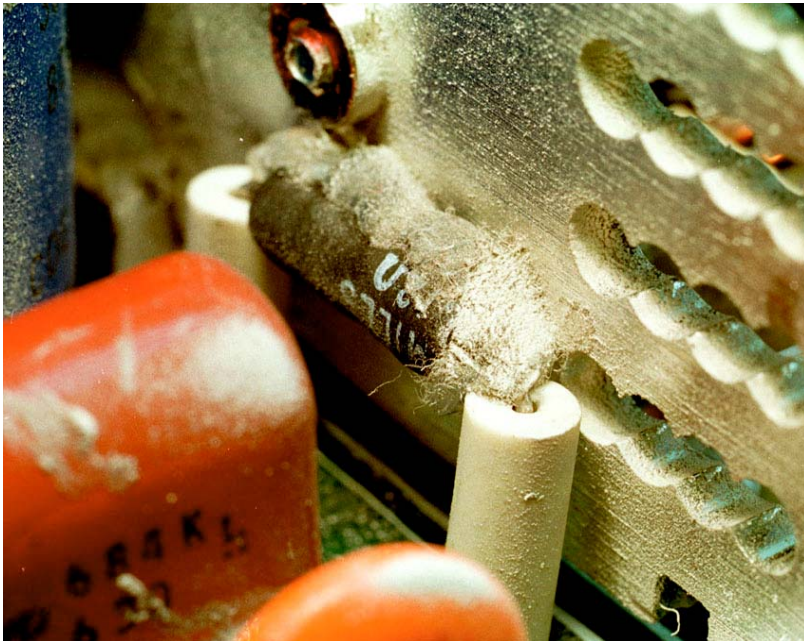
Dust and debris at component location R76
