PARTIAL Power Quality Report Sample

This report contains the results of our initial study. Power quality data was collected at three locations for a total of five 7-day periods as follows: (please note that ##### site was monitored for comparison only – the analysis and recommendations in this report do not apply to this site)

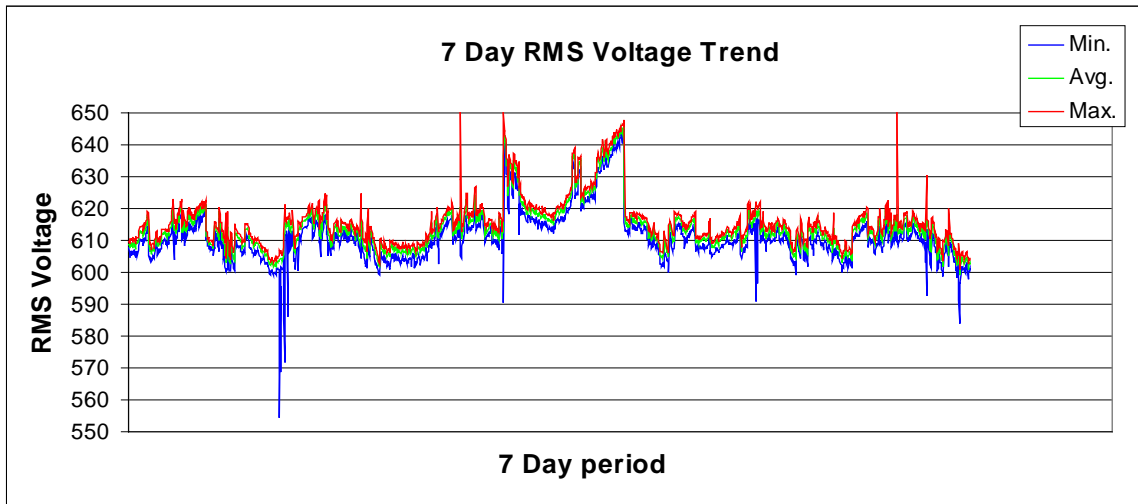
Figure 1: RMS voltage levels

RPM power monitors installed at ##### recorded many voltage anomalies that could affect drives within the facility. Figure 4 shows a seven-day recap of voltage levels at the site. RMS (root-mean-square) voltage levels reached 650 volts on more than one occasion and the median voltage is routinely around 610 volts.

These high rms voltage levels are high and can/will contribute to the effects of transient over-voltages. Further, the high voltage levels can cause the drive to trip off-line (as occurred on more than one occasion).

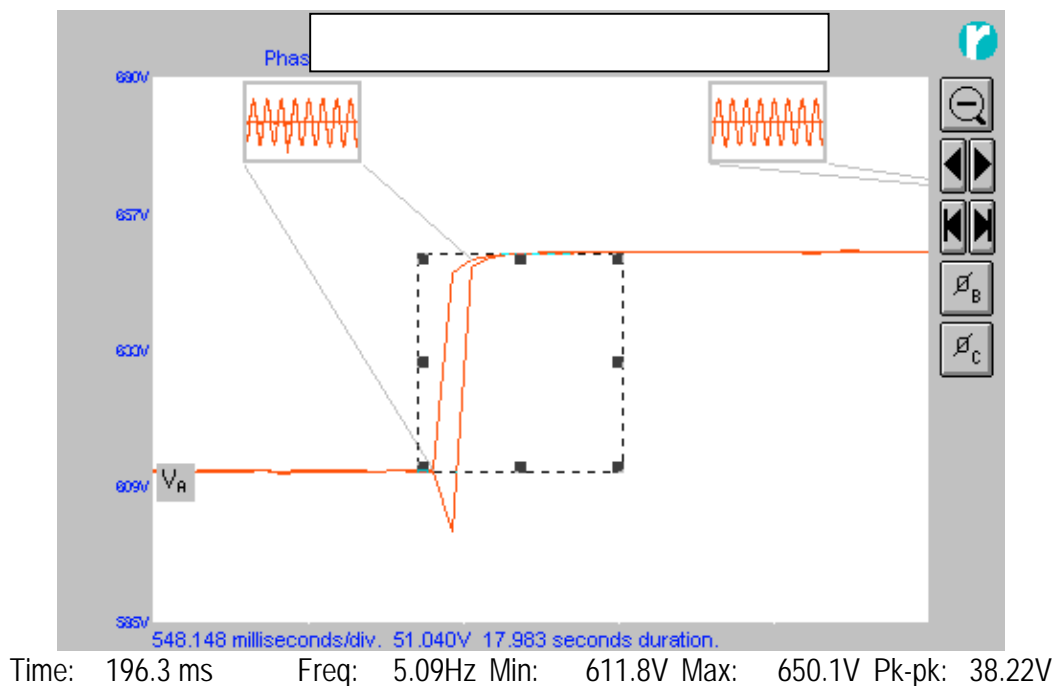
We have also noted that the rms voltage level during the sample time shown in figure 4 shows that at times the rms voltage either increases or drops by almost 40 volts within a few cycles. The exact cause of this phenomenon has not yet been determined. In this particular case the drives at the site shut down due to a high voltage condition and did not restart until rms voltage dropped below 630 volts (i.e. likely 575 +10% tolerance of drive). Severe voltage adjustment such as these can have an obvious serious operational impact on equipment sensitive to rms voltage swings. Further investigation of this situation should be performed to determine if this is an internal site problem or utility problem.

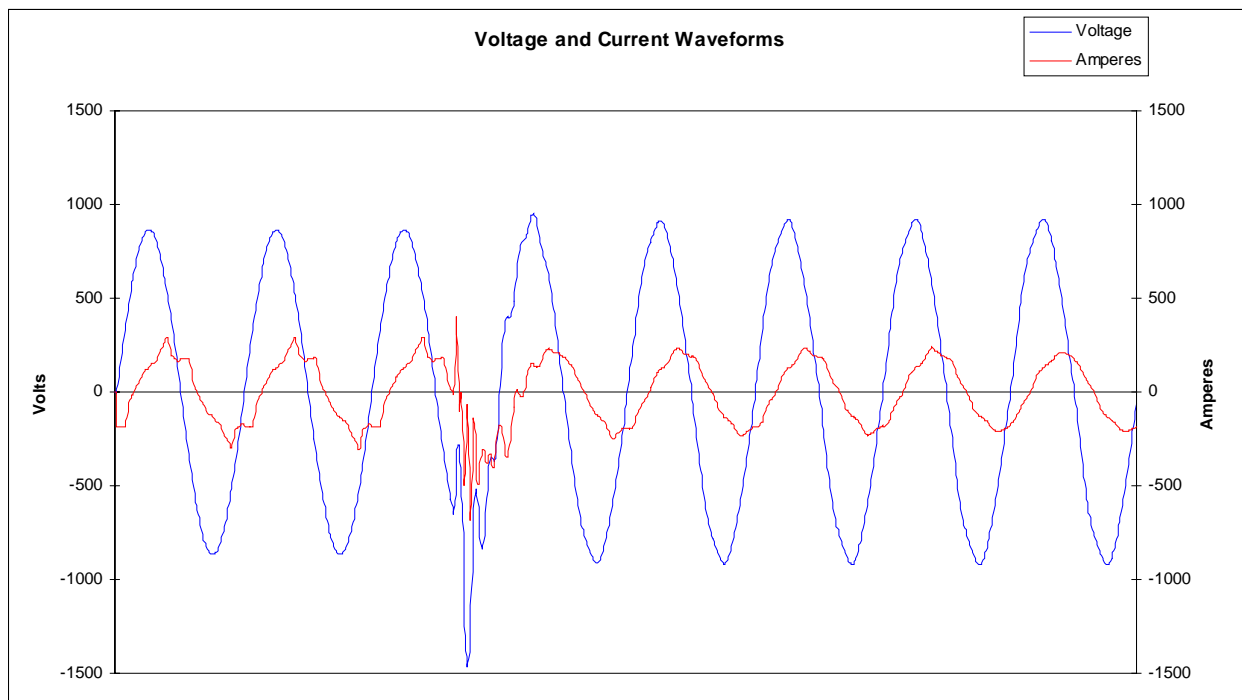
Figure 2: Event 890 (June 26th @ 07:28)

Figure 5 below shows one of the many transient over-voltage events recorded at the facility. This type of event is caused by the actuation of a bank of utility power factor correction capacitors. For this particular event the peak voltage reaches almost 1500 volts! Other similar events were recorded regularly (daily) with varying peak amplitudes depending on timing of capacitor bank switching (i.e. occurring at peak of voltage waveform). One must bear in mind, however, that the front-end components of the drives must survive the peak-to-peak voltage so the effects of the event are intensified by that condition.

During our monitoring period, we attempted to determine if internal facility power factor correction capacitors were an aggravating agent in terms of the magnitude of the recorded transient over-voltages. Results were inconclusive. We would require simultaneous monitoring with a monitor at “pre” and “post” internal capacitor bank locations at the site in order to determine if transient voltages are actually less when out of circuit. It was beyond the scope of this study to provide multiple monitors for this analysis.
