SAMPLE THERMOGRAPHIC REPORT AND STUDY

Marc A. Belanger, P.Eng.
PowerCET Canada
Better Technologies Corporation

THERMOGRAPHIC STUDY REPORT

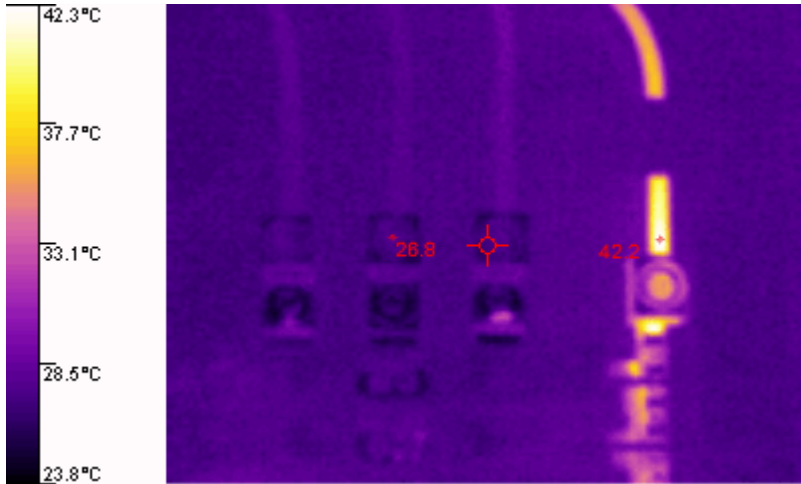
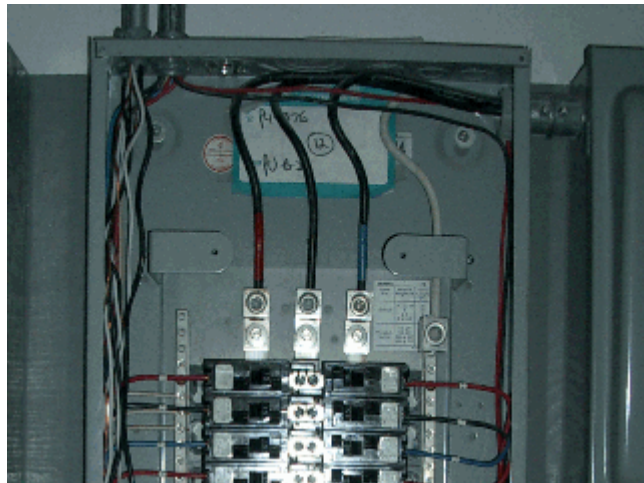
Location Name Room 256-2 Panel PUB2

Location	Equipment	Anomaly Status
Room D-003	Starter B004-EF	intermediate
Room 256-2	Panel PUB2	intermediate
Room 140-1	Panel PSA1	minor

Equipment Panel PUB2 Neutral

Hot Neutral Conductor - Check loads- torque - Investigate possible faults.

Image Date	26/05/2005 11:18:33 AM
Target Temperature	26.5 °C
Emissivity	0.85
Reflected Temp	OFF

Subj. Rating	high
Temp. Rating

Description	Repaired by
Hot Neutral. Check loads- torque - Investigate.

Check loads- torque - Investigate possible faults.

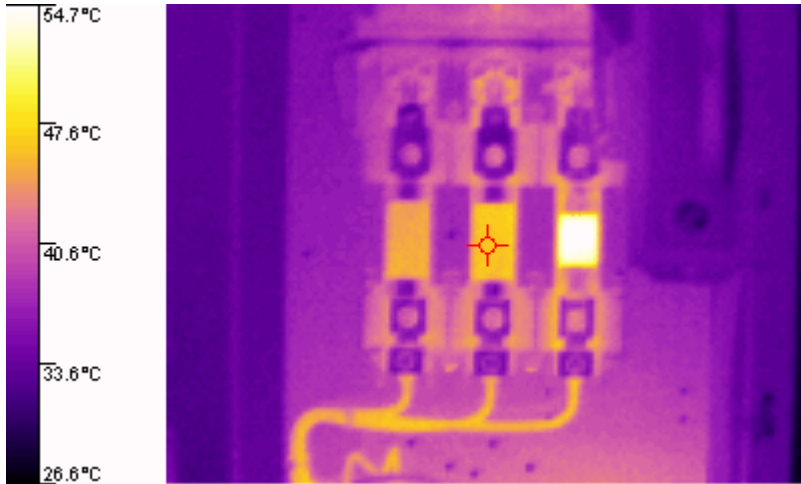
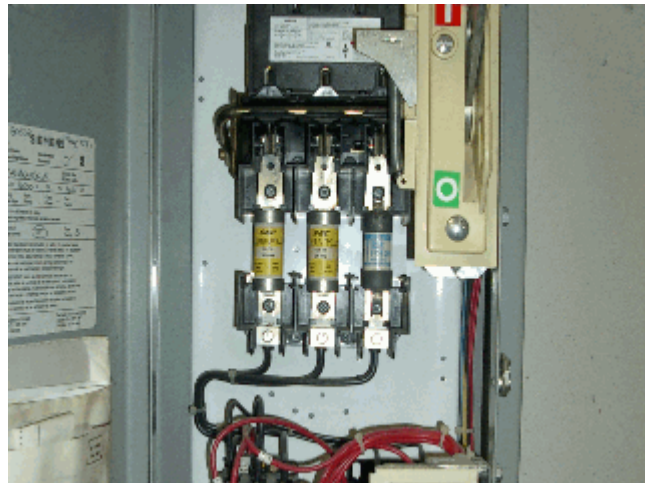
Location Name Room D-003, pump B004-EF

Equipment B004-EF starter

One fuse (right) is rated at 20 amps while the others are 30 amps

Image Date	25/05/2005 3:17:10 PM
Target Temperature	45.5 °C
Emissivity	0.85
Reflected Temp	OFF

Subj. Rating	high
Temp. Rating

Description	Repaired by
Ensure fuses are properly installed and rated.

Ensure fuses are properly installed and rated.

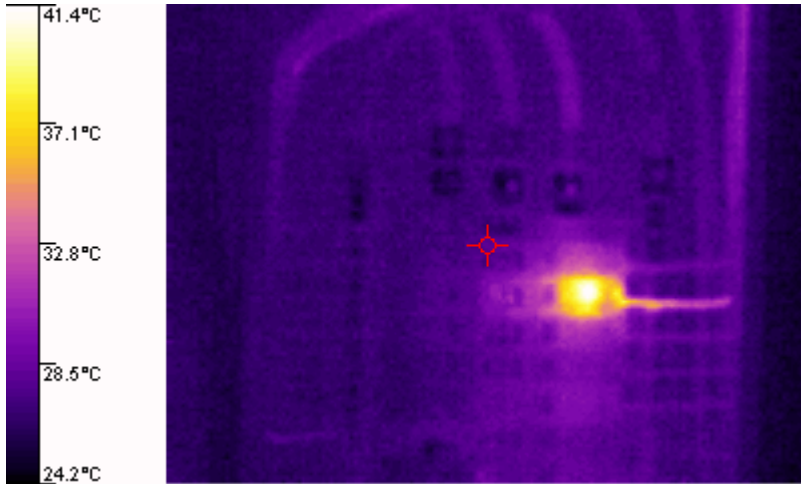
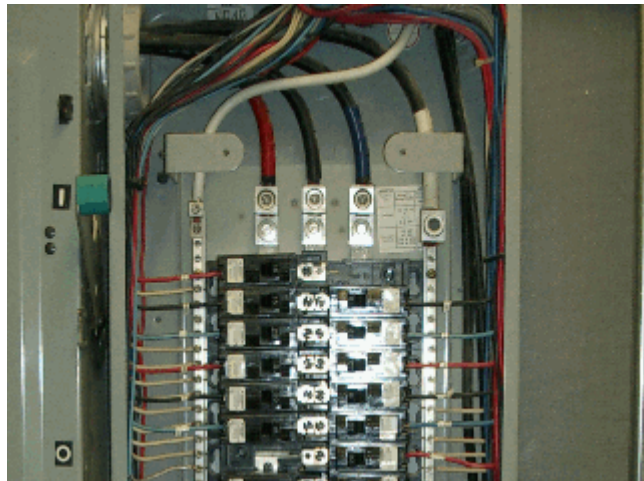
Location Name Room 140-1 Panel PSA1

Equipment Panel PSA1

Warm Circuit Breaker

Image Date	26/05/2005 9:10:19 AM
Target Temperature	28.0 °C
Emissivity	0.85
Reflected Temp	OFF

Subj. Rating	low
Temp. Rating

Description	Repaired by
Check load - torque - Investigate.

Check load- torque - Investigate.
